BATTERED BRIDGE

State's second-longest covered bridge prepped for restoration

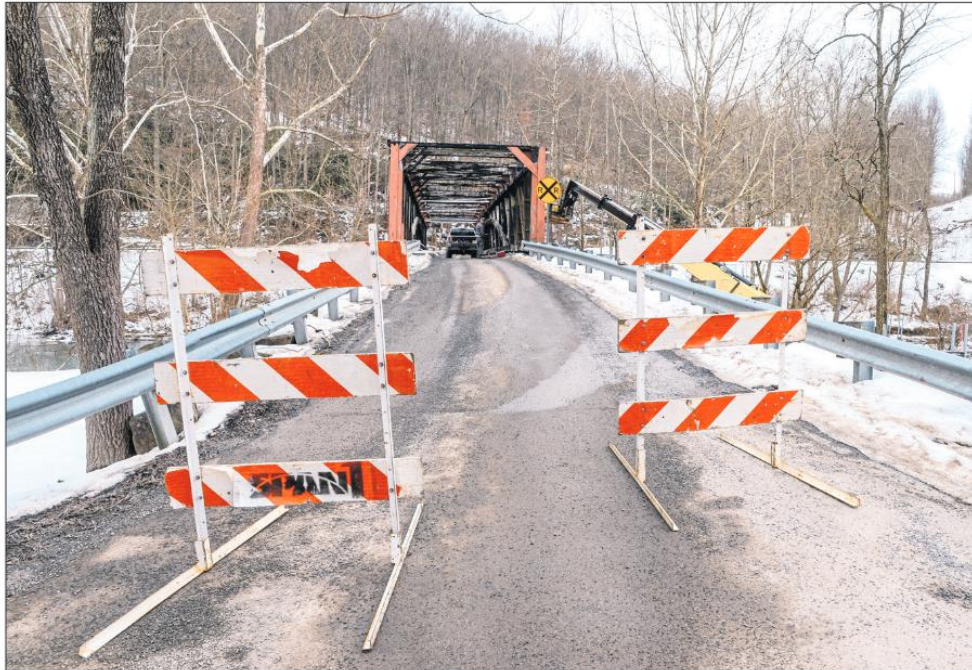
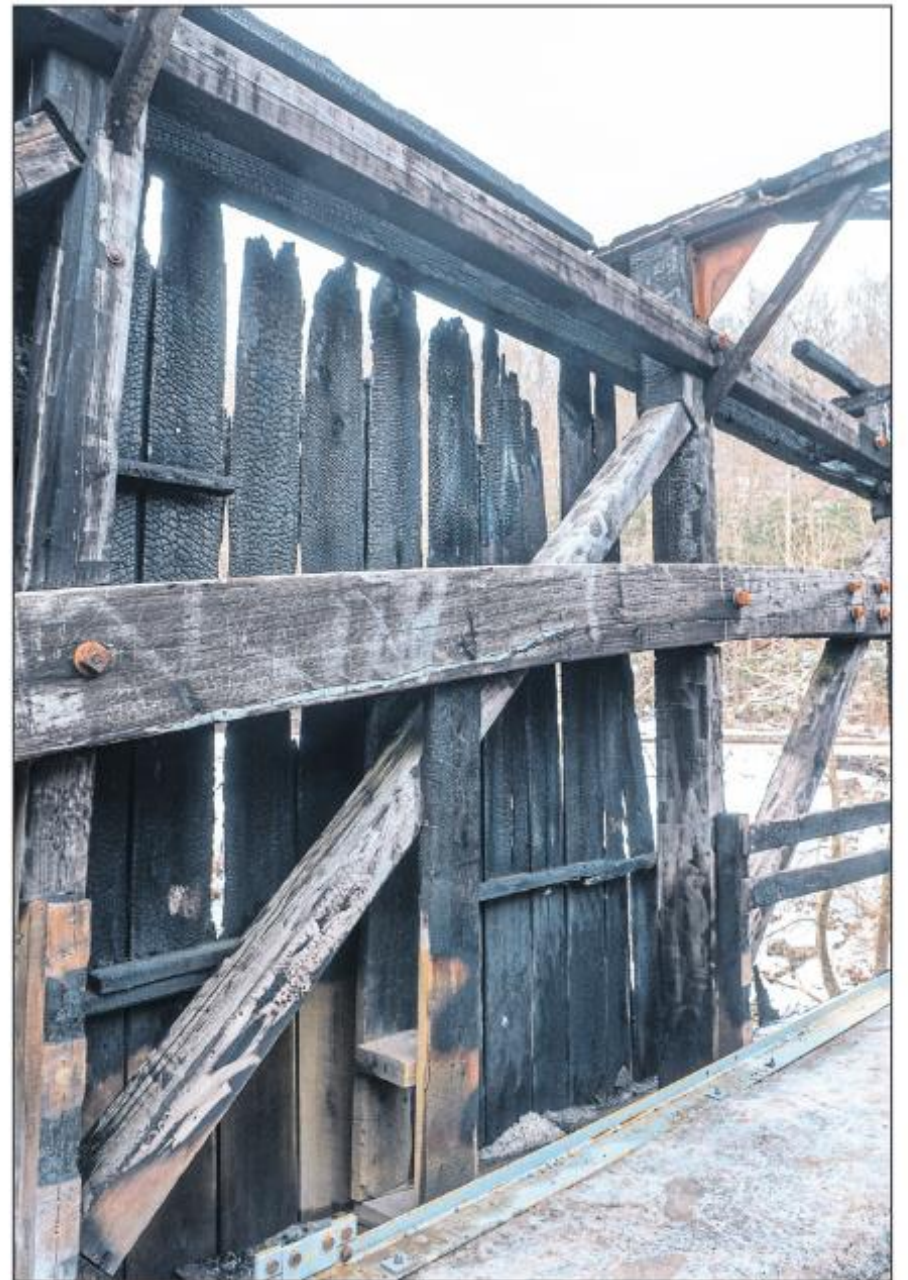
ABOVE: As workers from Span 1 LLC of Scott Depot take stock of the covered bridge's interior, traffic on Carrollton Road is temporarily blocked. **RIGHT:** While the 2017 fire destroyed the span's vertical board and batten walls, most larger support timbers, though singed, remained structurally sound and will be used in the covered bridge's restoration.

While the fire sent the historic span's roof and distinctive barn-red board-and-batten siding up in smoke, most of its larger wooden support beams and arches, though charred, were salvageable, thanks in large part to heroic efforts by area firefighters.

In the weeks following the fire, consultants from the Mead & Hunt engineering firm determined which portions of the wooden superstructure could be saved, then installed temporary bracing to support what remained of the roof. Following minor repairs to the modern bridge superstructure — a concrete deck and support piers installed during a 1963 rehabilitation project — the bridge reopened to traffic in September 2017.

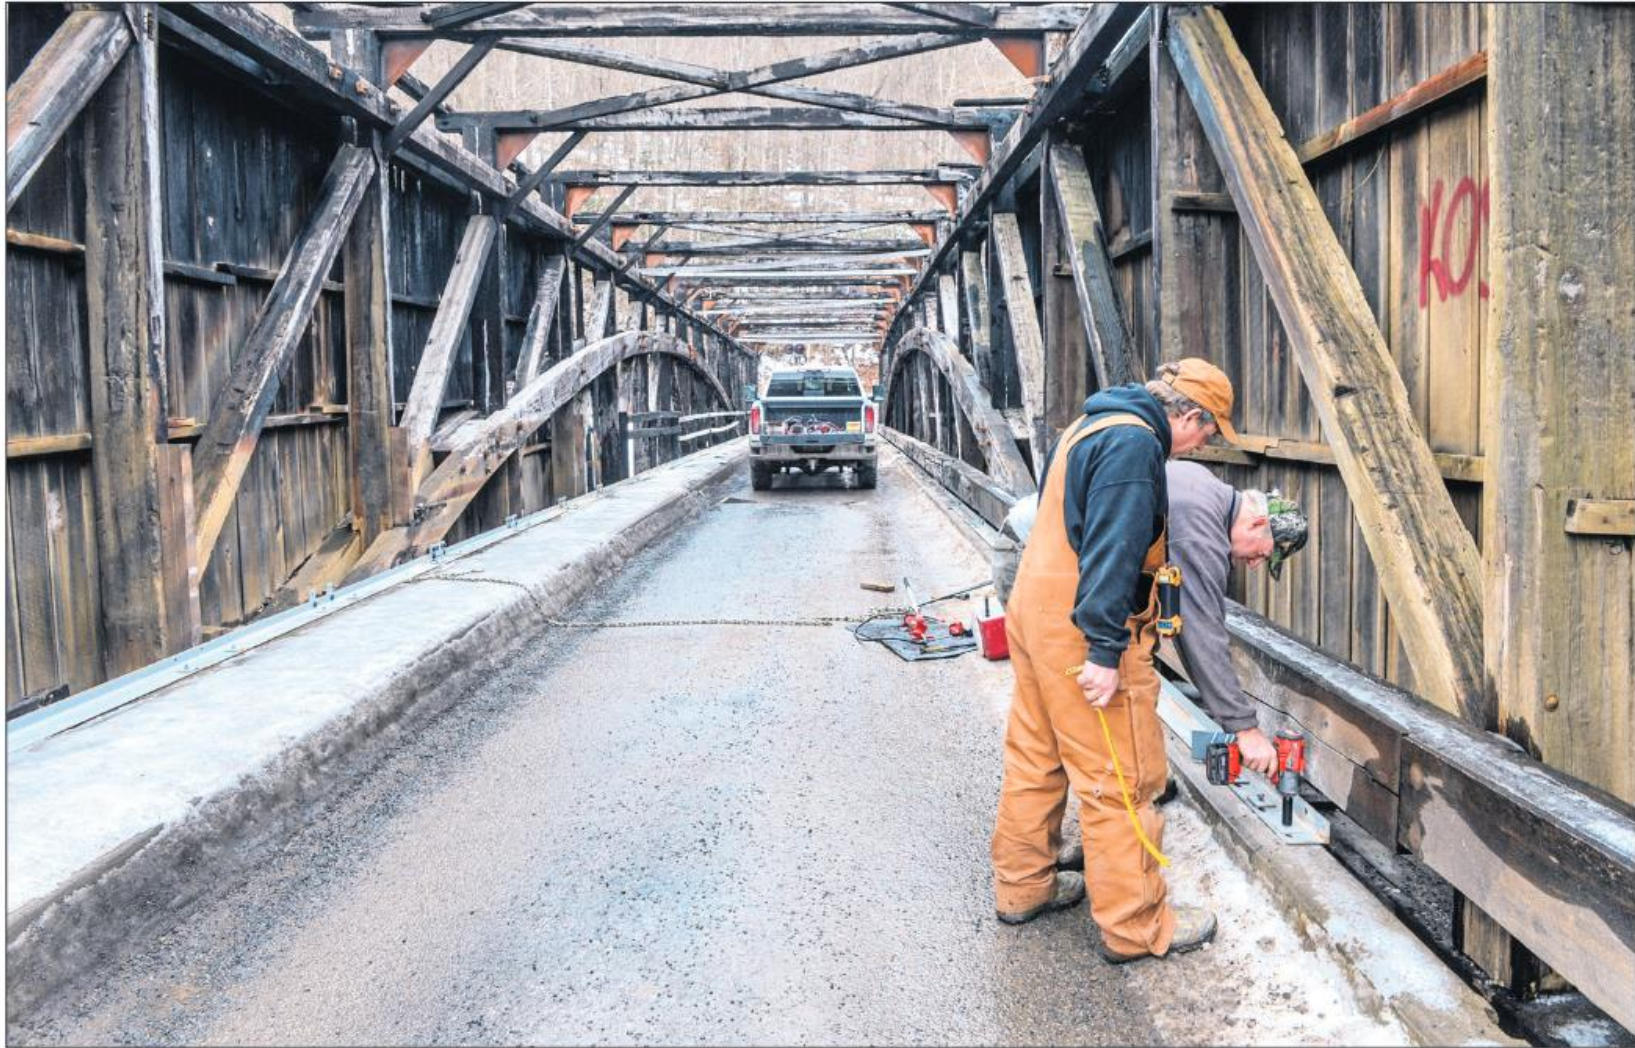
Span 1 LLC workers secure angle iron to the Carrollton Covered Bridge in preparation for restoration work.

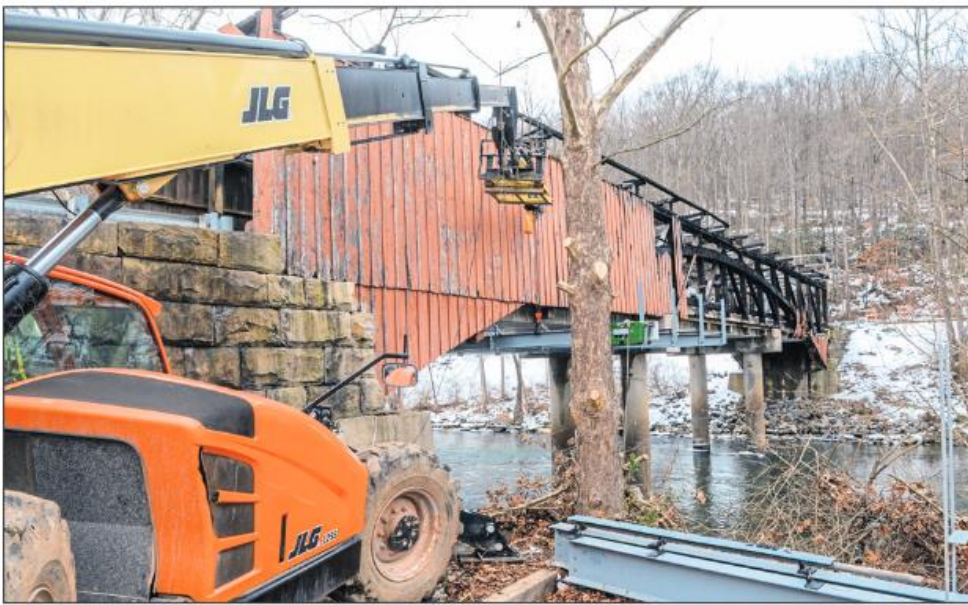
Beams used to support scaffolding are being installed at the 166-year-old Carrollton Covered Bridge. Once the scaffolding is in place, a team from the Division of Highways' District 7 bridge section will begin restoration work on the arson-charred span.
