Chandelier Returning to Capitol Rotunda

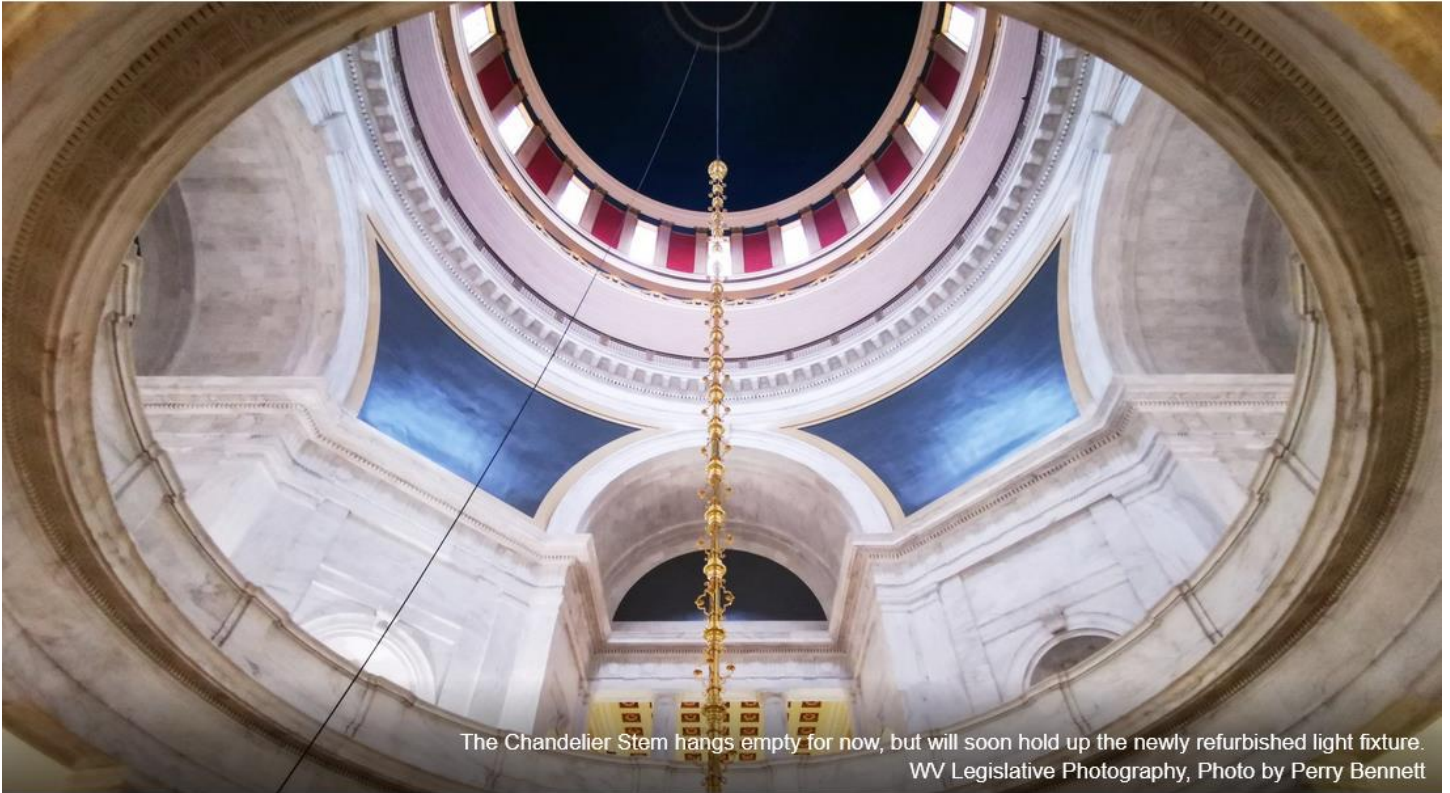
The Chandelier Stem hangs empty for now, but will soon hold up the newly refurbished light fixture. WV Legislative Photography, Photo by Perry Bennett

The chandelier is eight feet in diameter and has a 55 foot stem. The difficult task of reinstalling it is now underway. The work is expected to take a couple of weeks. As part of the renovation to the dome a new system was installed to help raise and lower the chandelier for cleaning and maintenance. A secondary system was also added. According to McVey the secondary system is a safe guard against the massive glass ball crashing to the lower rotunda.

“It is a completely new and redesigned winch system for raising and lowering as we need to. Rather than just having one way of getting it up and down we actually put a redundant secondary system on it in case the primary fails. With that secondary attachment, it will not fall,” McVey explained.

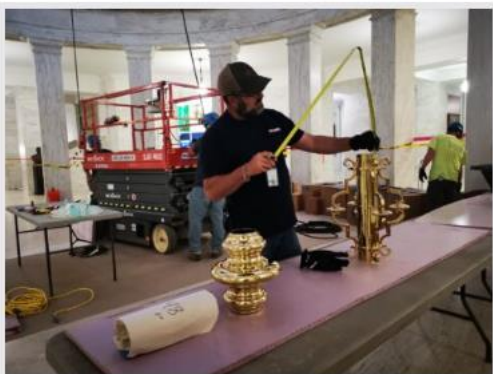
A worker re-assembles the massive stem to uphold the chandelier in the Capitol rotunda. WV Legislative Photography, Photo by Perry Bennett

According to McVey, the company took the massive chandelier apart piece by piece and gave it a complete overhaul. New lighting fixtures were added and rewired, every single piece of crystal in the globe was individually cleaned, and a new steel cable was installed in the stem to help with support. Once all of the work was done, the chandelier was placed into storage in the New Hampshire facility until it was transported back to Charleston last week.
